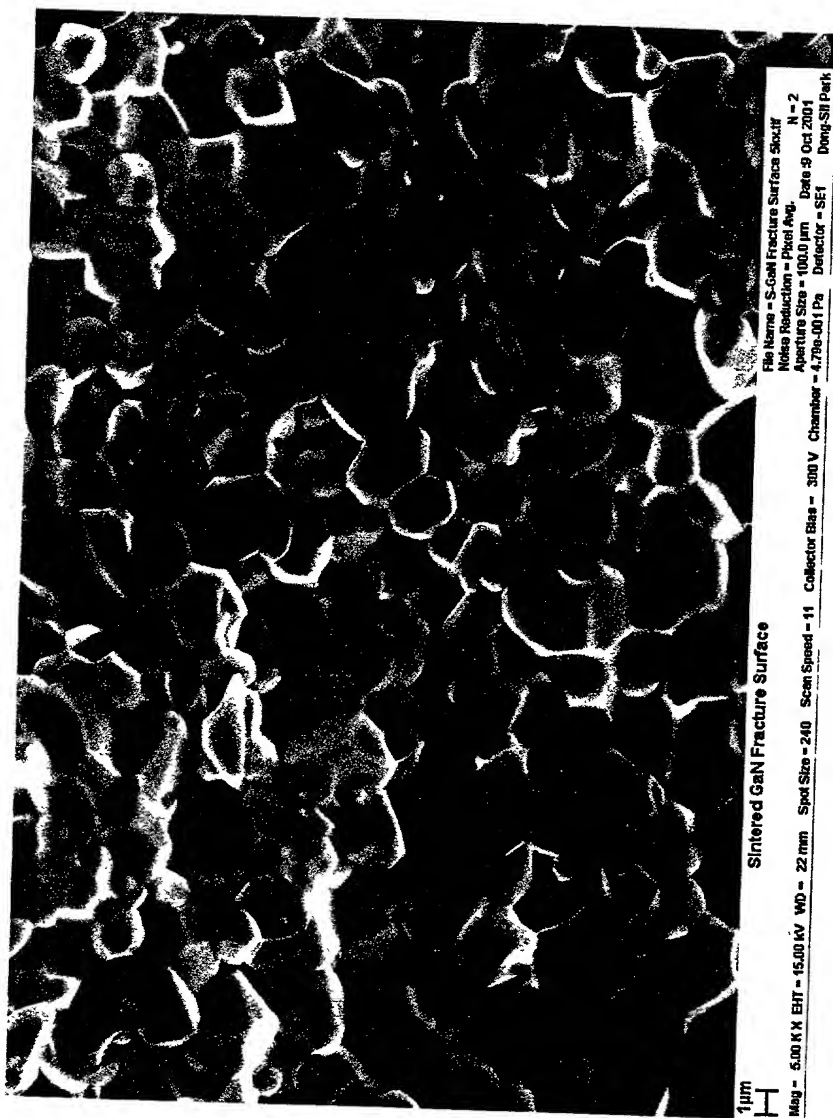
**FIG. 1**

1 μm  
Sintered GaN Fracture Surface  
File Name = S-GaN Fracture Surface Size.tif N = 2  
Noise Reduction = Prol. Avg.  
Aperture Size = 100.0 μm Date = 9 Oct 2004  
Mag = 5.00 KX EHT = 15.00 kV WD = 22 mm Spd Size = 240 Scan Speed = 11 Collector Bias = 300 V Chamber = 4.79e-001 Pa Detector = SEI Dong-Su Park

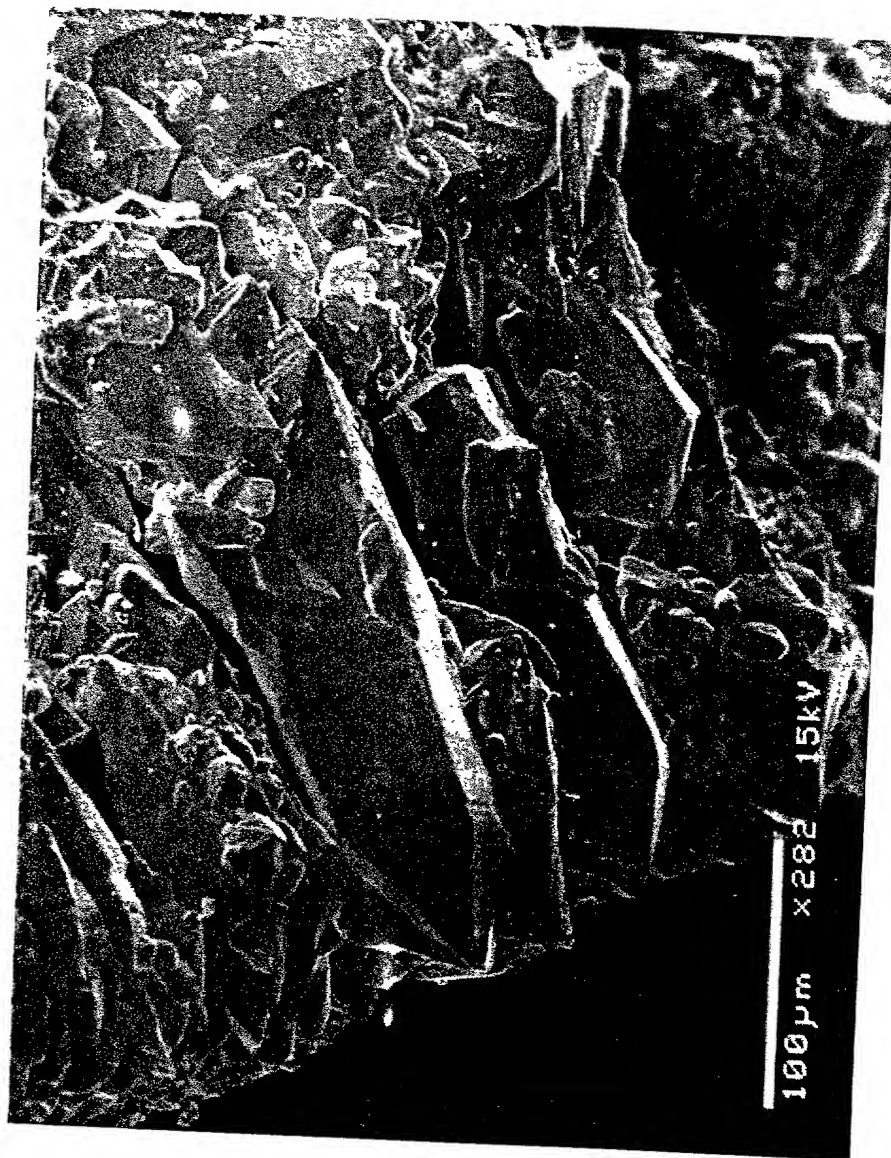
FIG. 4

Scanning electron micrograph (SEM) of a fractured surface. The image shows a complex, rough, and irregular fracture pattern with sharp edges and deep crevices. A scale bar in the bottom right corner indicates 100 μm. Technical data in the bottom right corner includes X282 magnification and 15kV voltage.
